# METALLURGICAL EVALUATION OF FAILED AIRCRAFT STAINLESS STEEL EXHAUST SYSTEM COMPONENTS

TECHNICAL REPORT

by  
T. H. McCunn  
Allegheny Ludlum Steel Corporation  
Research Center  
Brackenridge, Pennsylvania  
Under Contract FA NAF-176

ADS-28

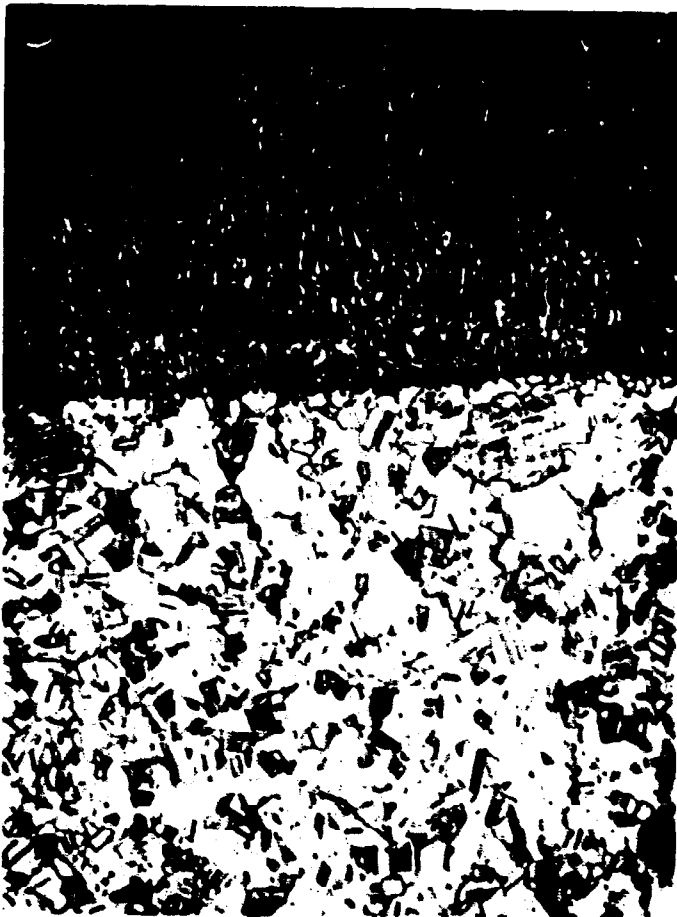
FIG. 2 SAMPLE NO. 1, SHOWING NORMAL STRUCTURE

BASE METAL AT BOTTOM AND  
WELD METAL AT TOP, SHOWING  
SOME GRAIN GROWTH IN HEAT-  
AFFECTED ZONE.

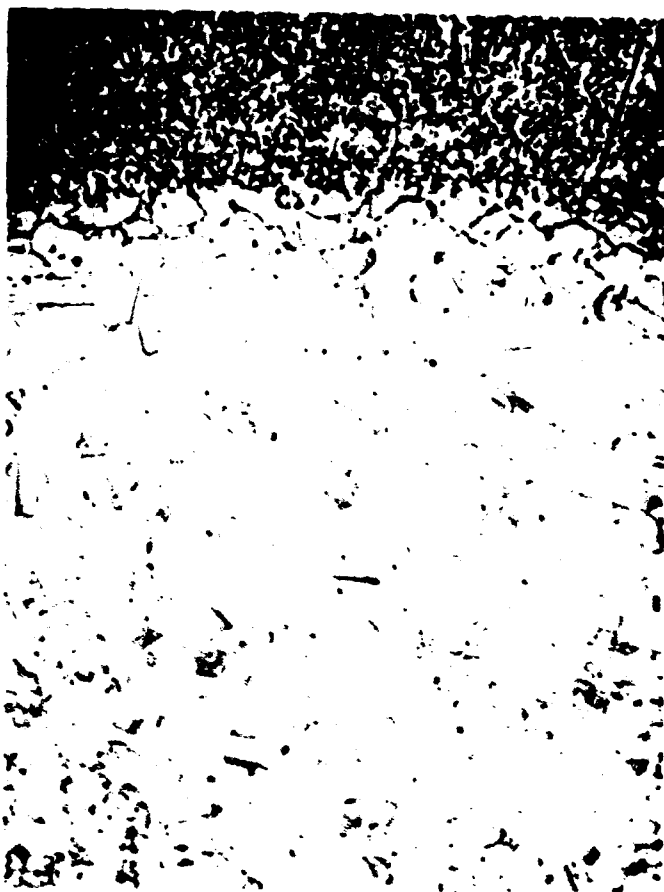
FIG. 5

STRUCTURE OF LARGER  
EXHAUST PIPE OF SAMPLE  
NO. 2 IN AREA OF FLATTER  
WELD, SHOWING WELD,  
HEAT-AFFECTED ZONE,  
AND BASE METAL.

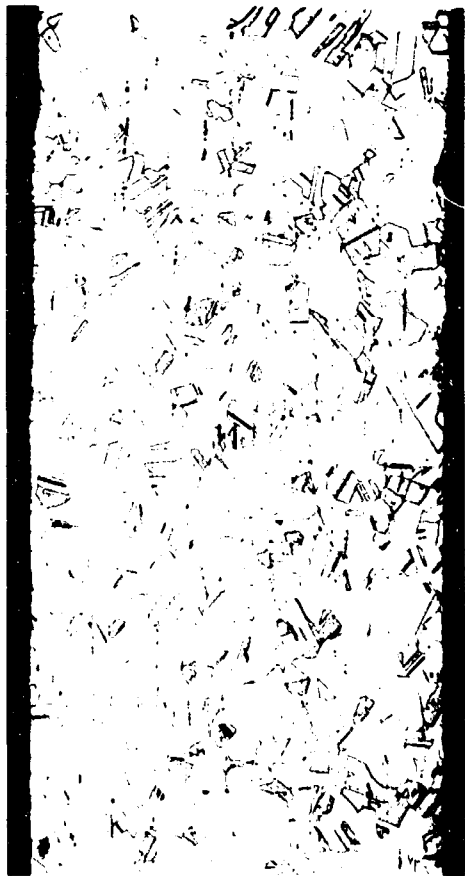
FIG. 8

STRUCTURE OF TYPE 321  
BASELINE EXHAUST PIPE,  
SAMPLE NO. 3.

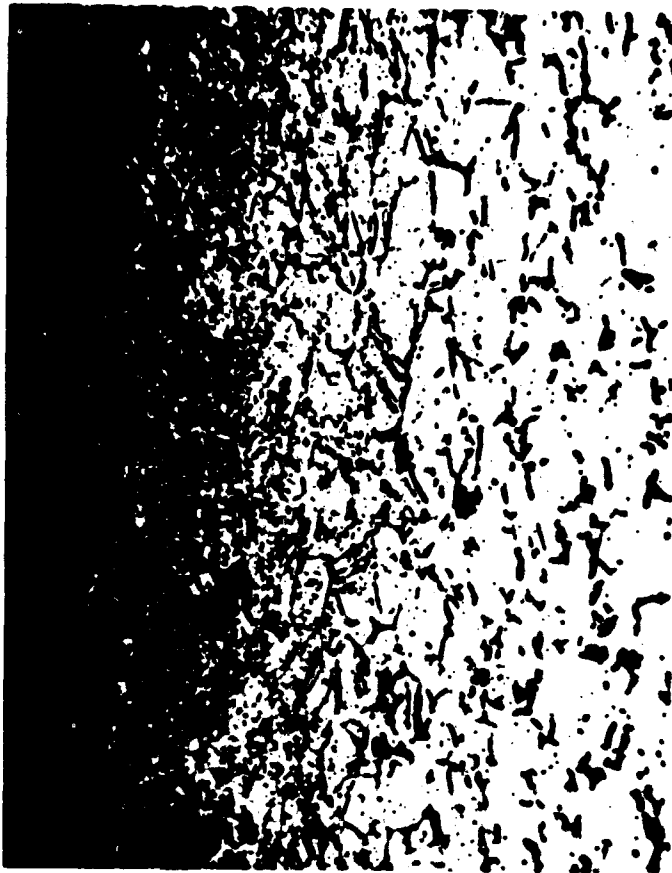
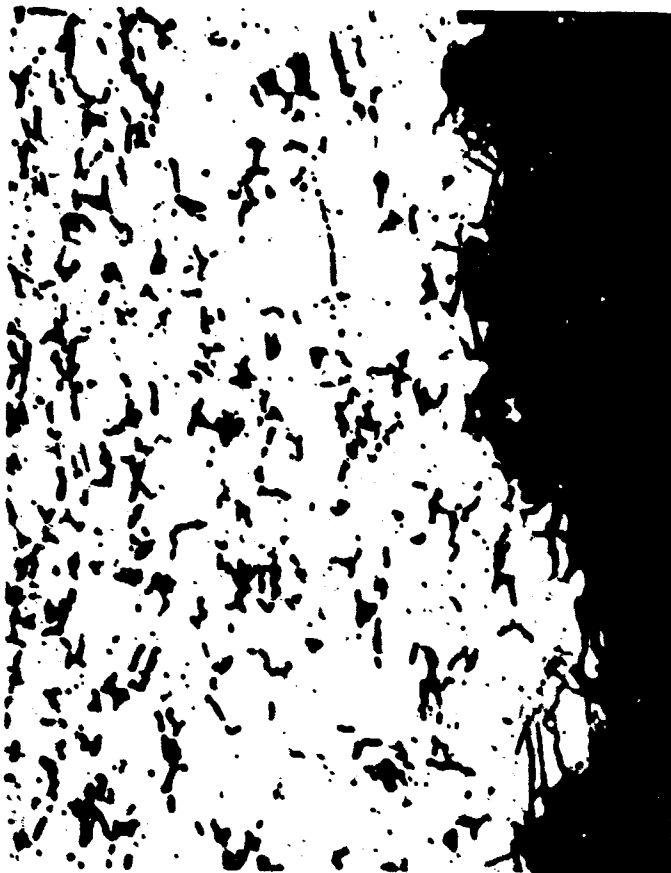
FIG. 14 STRUCTURE OF SAMPLE NO. 5 SHELL

The microstructures at the two locations after etching are shown in Figures 13 to 15. At both locations the structure contained sigma phase, distributed discontinuously in the grain boundaries. In addition, the grain boundaries appear broad. This appears to be due to an etching effect which suggests that the composition of the boundaries is different from that within the grains. Besides the presence of sigma phase, the inside surface of the shell at the bulged area shows carburization to have occurred.

INSIDE SURFACE SHOWING  
CARBIDES AND SIGMA PHASE

OUTSIDE SURFACE SHOWING  
SIGMA PHASE

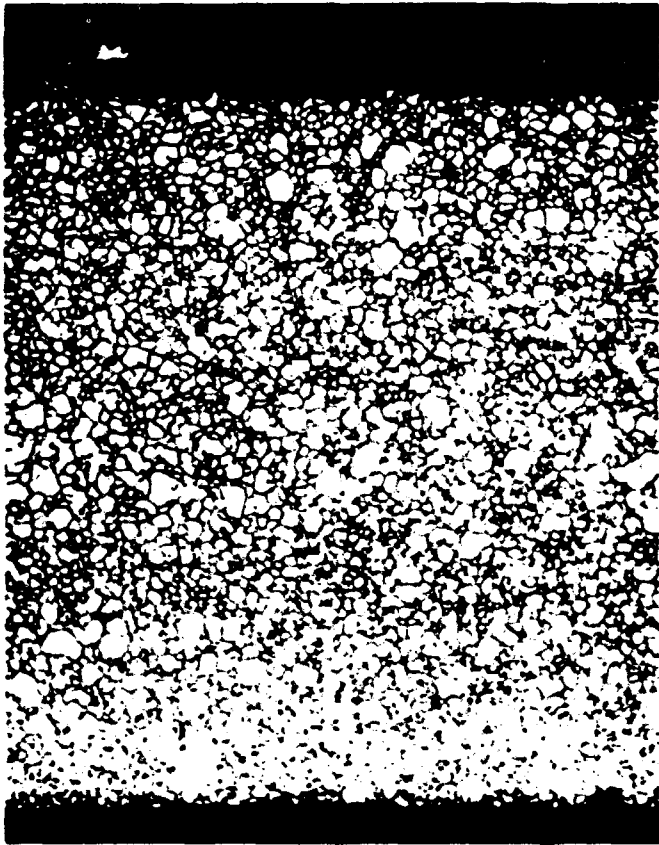
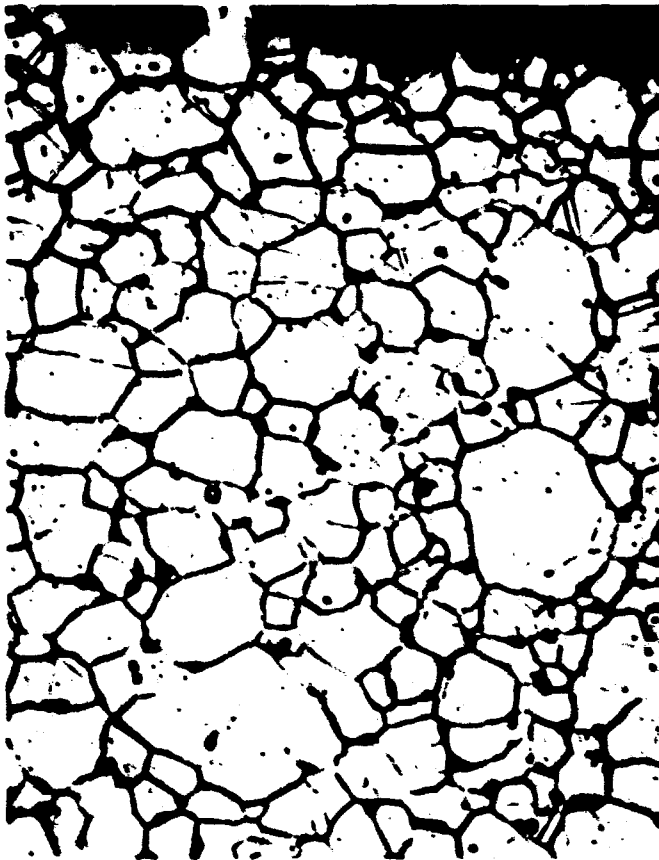
FIG. 15 STRUCTURE OF SAMPLE NO. 5 SHELL AWAY FROM BULGED AREA, SHOWING SIGMA PHASE IN GRAIN BOUNDARIES

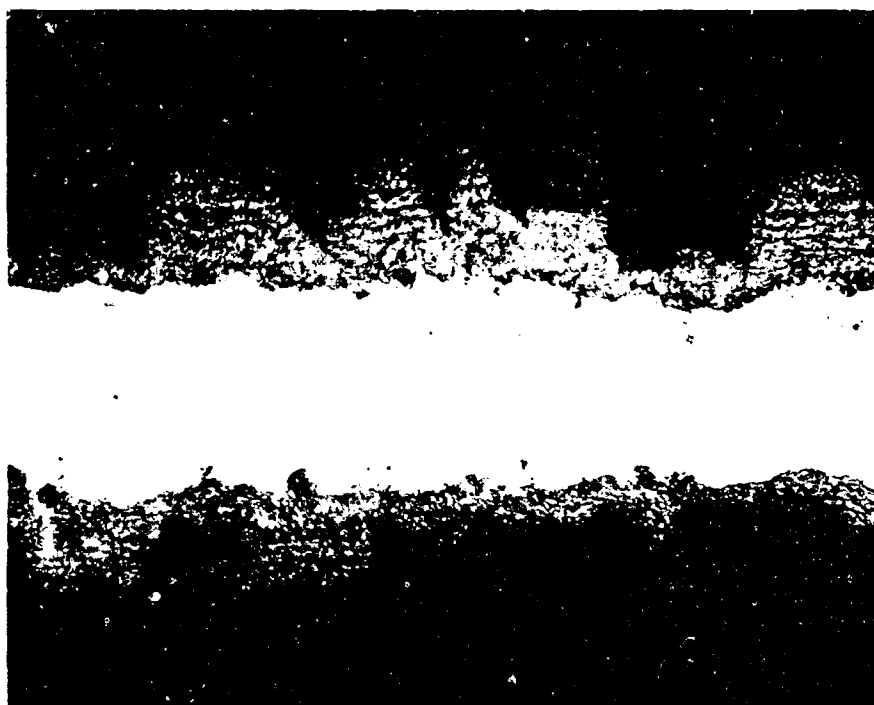
FIG. 17 SAMPLE NO. 6 - INTERNAL BAFFLE, SHOWING HEAVY OXIDATION

Figure 17 shows that the material was heavily oxidized. Etching revealed a microstructure through the entire cross-section of many carbides and grain boundary sigma similar to the structure shown in Figure 14A at the surface.

Corrosion product was scraped from the baffle. An X-ray analysis showed  $\text{FeO} \cdot \text{Cr}_2\text{O}_3$  spinel and  $\text{Pb}(\text{Fe}, \text{Mn}, \text{Al}, \text{Ti})_{12}\text{O}_{19}$ .

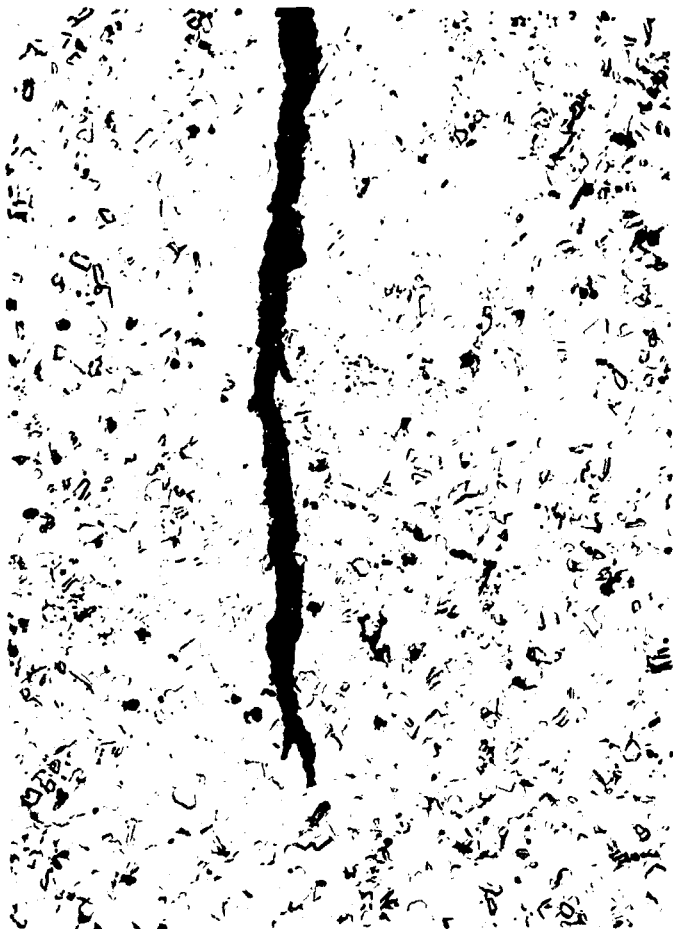
FIG. 20

One specimen for metallographic examination was taken at the end of the crack through the hole of the support. Figure 20 indicates the crack to be the result of fatigue. The presence of titanium carbonitrides indicates that this support section was Type 321 also. The microstructure was essentially free of finer carbides.

SAMPLE NO. 7 - SHOWING  
END OF CRACK THROUGH  
HOLE IN SUPPORT PIECE

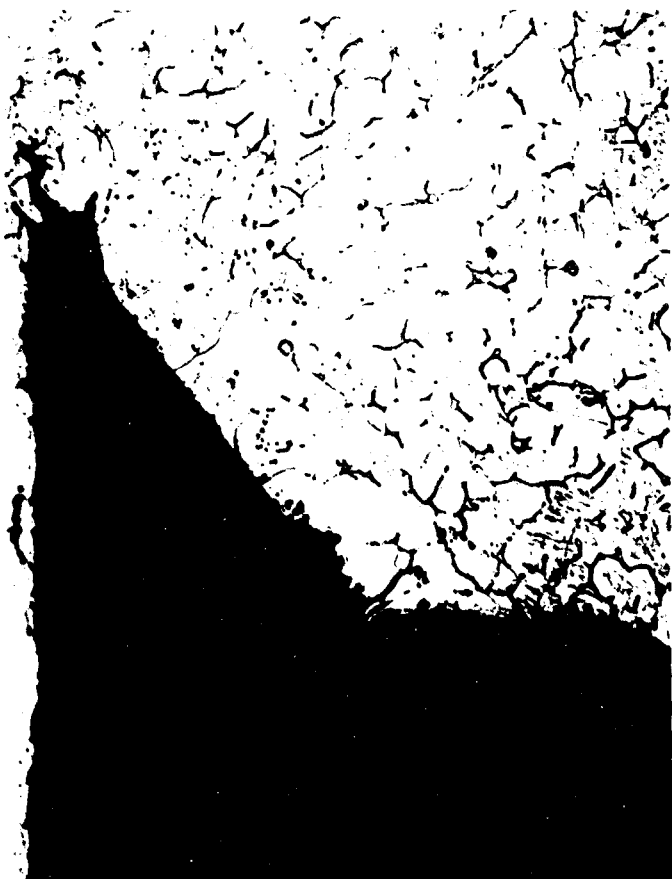
FIG. 21

Another specimen was cut through the crack at the weld. The pieces fell apart so that the specimen examined metallographically essentially consisted of a piece of the tubing and the fusion weld. Figure 21 shows where the shell had been joined by welding to the tubing. It is believed that the straight edge is part of the crack through the heat-affected zone. Note that the amount of delta ferrite along this edge of crack surface is somewhat less than that in the weld, thus suggesting that this is the heat-affected zone. The straightness and the transgranular course of the crack in addition to little evidence of deformation indicate failure by fatigue. While not shown by a photomicrograph, the tube had a normal microstructure where it was not exposed to the hot gases. The portion of the tube within the shell showed a continuous grain boundary precipitate, starting somewhat beyond the heat-affected zone. Within the heat-affected zone, the grain size was large due to the fusion welding, but there was no grain boundary precipitate. The difference here is believed to be due to the temperatures attained during operation rather than to effects of the fusion welding. The crack between the weld and the support also appeared to be caused by fatigue as it was relatively straight and transgranular. The crack was for the most part in the heat-affected zone.

SAMPLE NO. 7 - SHOWING  
FUSION WELD WHERE SHELL  
WAS JOINED TO THE TUBE.  
A SMALL PORTION OF THE  
TUBE IS ON THE LEFT

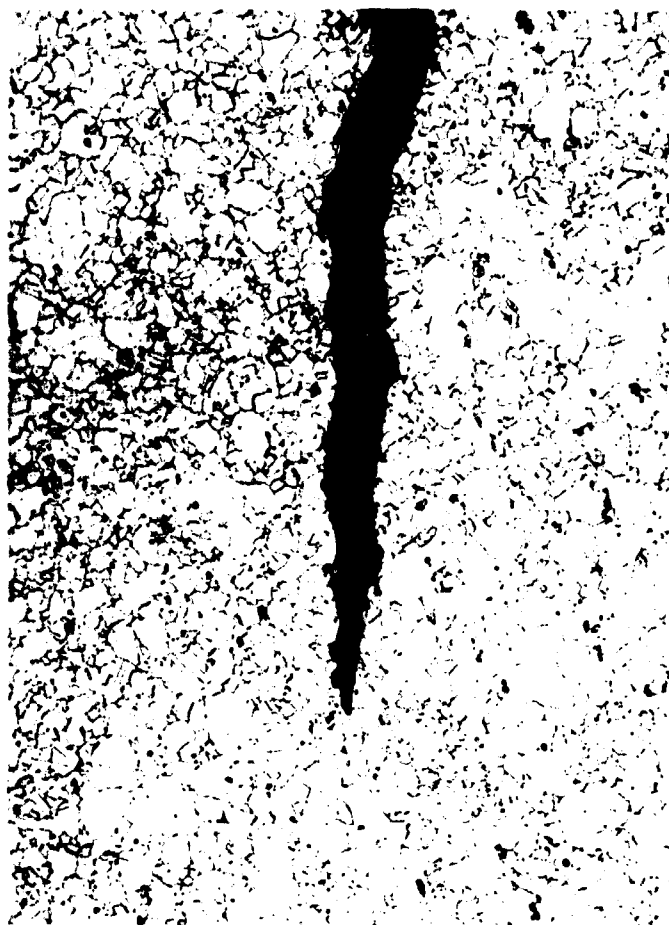
Another specimen was taken at the end of the crack in the shell which can be seen in Figure 19 just above the tube. The crack is shown in Figure 22. It also appears to be a fatigue crack. The microstructure shows a continuous grain boundary precipitate similar to that observed in the portion of the tube which was inside the shell and exposed to the hot gases.

FIG. 22 SAMPLE NO. 7 - SHOWING END OF CRACK IN SHELL WHICH  
CAN BE SEEN IN FIGURE 19 JUST ABOVE THE TUBE.

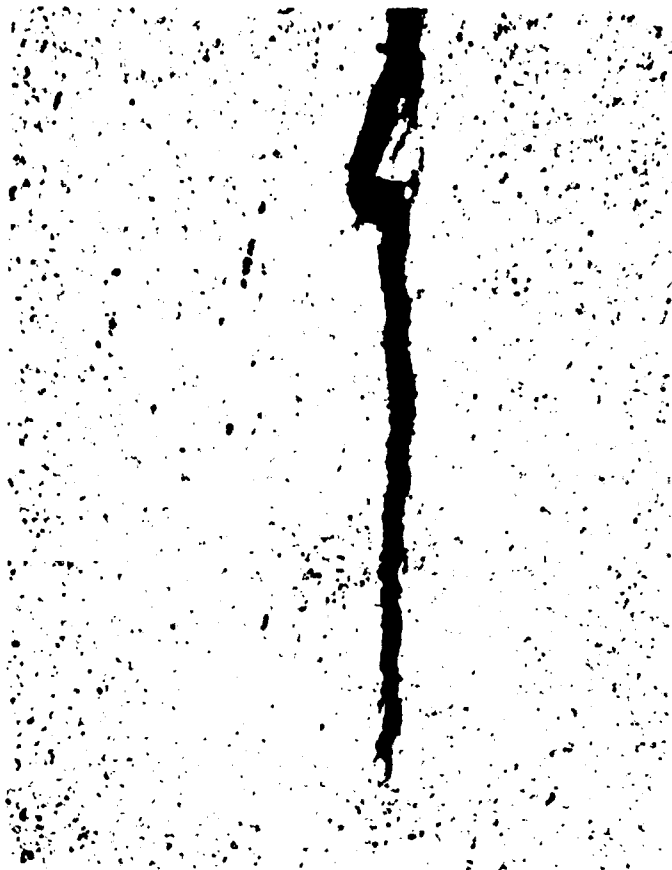
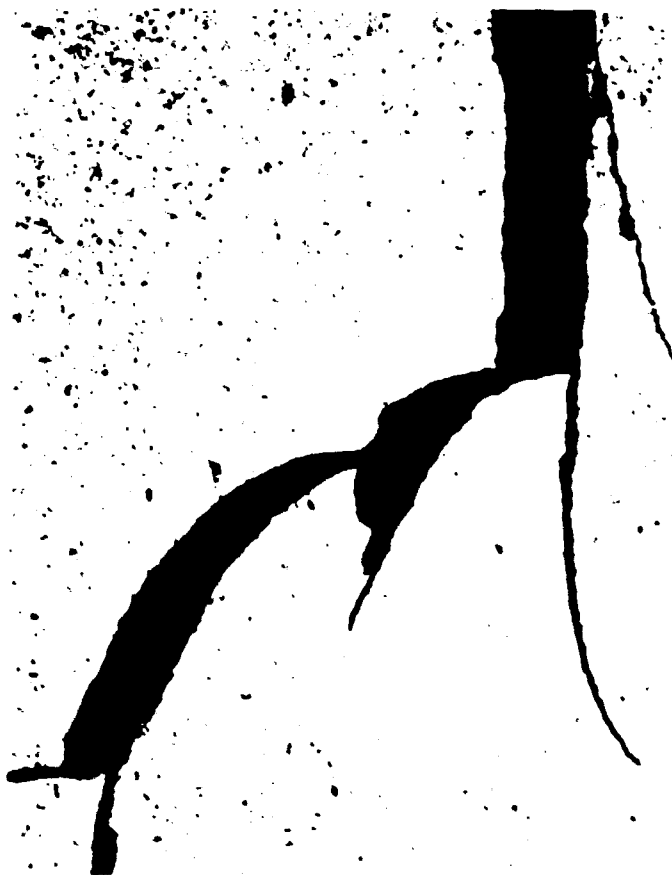
FIG. 25 SAMPLE NO. 8 - SHOWING (A) END AND (B) ANOTHER LOCATION OF CRACK IN SHELL

A specimen for metallographic examination was taken at the end of the crack extending in the shell at four o'clock from the tube. Figure 25 shows the end of the crack and another location of the crack where it seems to have been changing direction. The crack appears to be a fatigue failure. A specimen taken to show the cross-section of the shell confirmed that the microstructure of the shell of this muffler, unlike that of Sample No. 7, did not have a grain boundary precipitate, indicating that this muffler operated at a lower temperature or for a shorter time than that from which Sample No. 7 was taken.

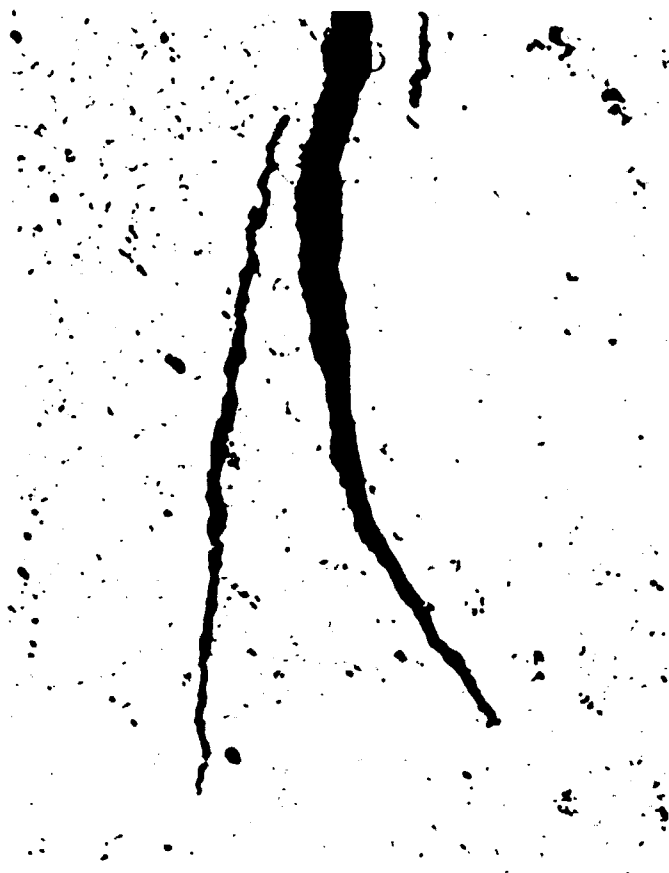
FIG. 27

A specimen for metallographic examination was taken at the end of the crack in the shell. An adjacent specimen was taken to view the cross-section. Figure 27 shows the end of the crack. While this crack had a few branches, it still appears to be a fatigue failure. As Figure 28 shows, the microstructure contained sigma phase and carbides. This material also had a few stringers of delta ferrite which had transformed to sigma phase. The indication is that this muffler operated at higher temperatures or for a longer time than Sample Nos. 7 or 8.

SAMPLE NC, 9 - SHOWING  
END OF CRACK IN SHELL

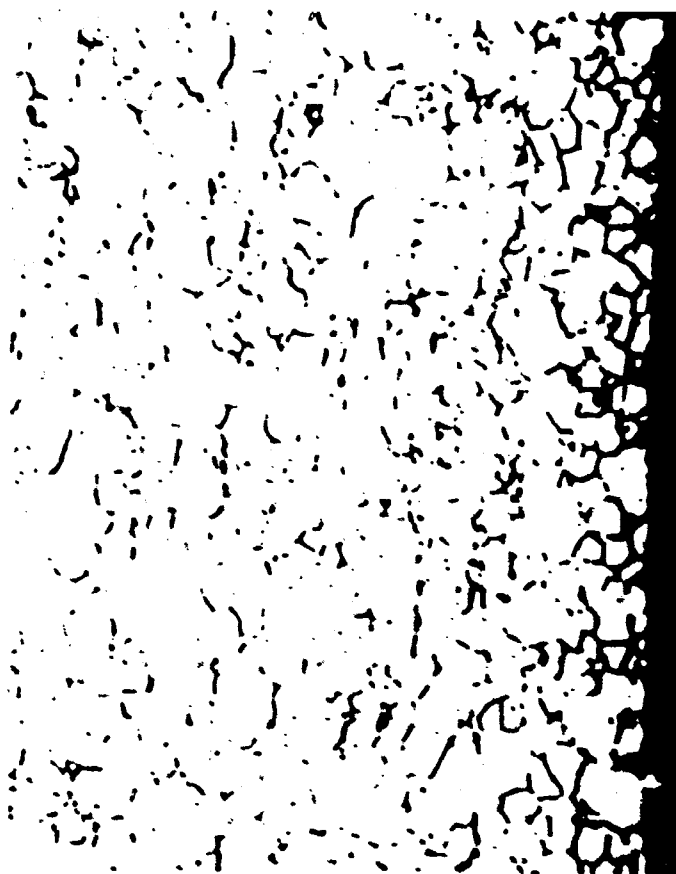
FIG. 28

SAMPLE NO. 9 - SHOWING  
STRUCTURE OF SHELL

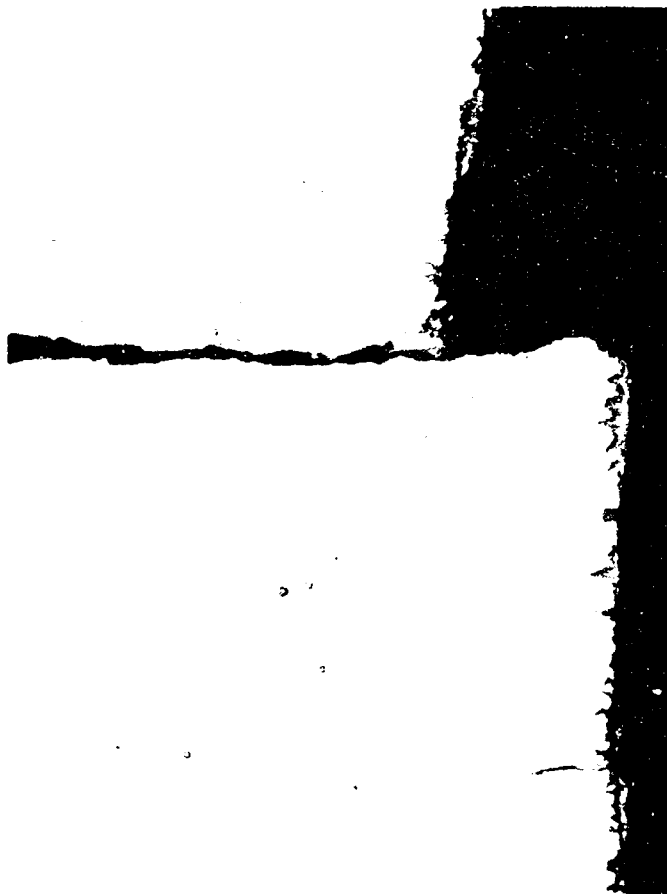
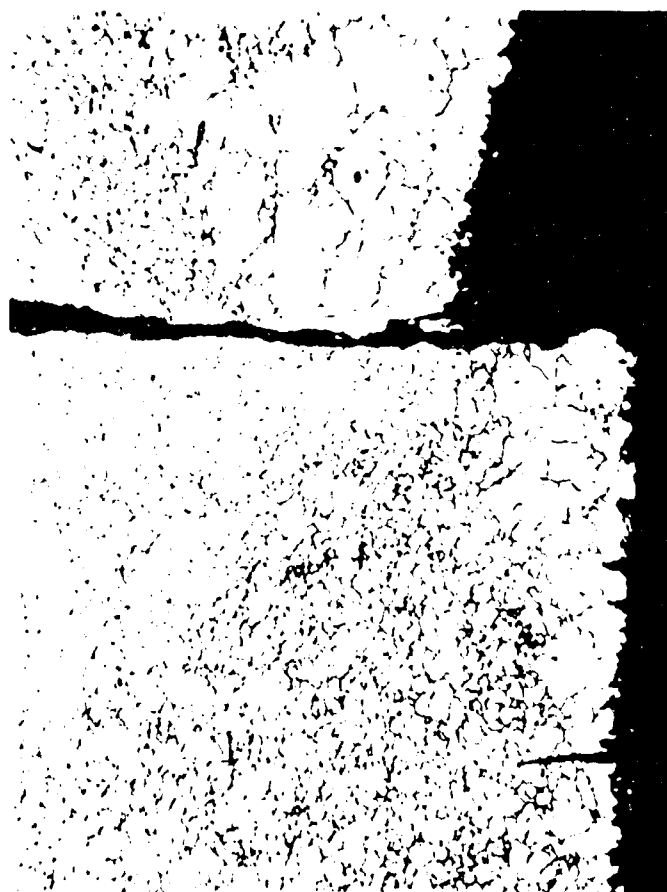
FIG. 31 SAMPLE NO. 10 - SHOWING CRACK IN SHELL

Since a specimen for metallographic examination to view the end of the crack was difficult to obtain because of the curved surfaces, a specimen was taken through the weld perpendicular to the plane of the crack in the shell. This specimen included portions of the tube, the support piece, and the shell. After the sample was polished, the crack through the shell extended all the way through the cross-section in the plane being viewed. This is shown in Figure 31 by the relative displacement of the two pieces.

Examination of this specimen showed a myriad of microstructures. First of all, the microstructures of the weld, the tube where it was outside the shell, and the support piece appeared normal. Similar to Sample No. 7, the structure of the portion of the tube within the shell had a continuous grain boundary network of carbides starting beyond the heat-affected zone, apparently because of different temperatures attained during operation. In the shell portion at the crack the microstructure showed a continuous grain boundary precipitate near the surfaces, but not near midthickness. The microstructure in Figure 31B shows this characteristic at the outside surface of the shell. Note that the surface shows some attack and that another short crack had started. There was a similar crack to a shallower depth on the outside surface but on the other side of the main crack. These cracks are transgranular and appear to be fatigue cracks. The microstructure of the shell in the heat-affected zone showed the usual large grain size but the grain boundary precipitate did not appear until near the unaffected base metal.

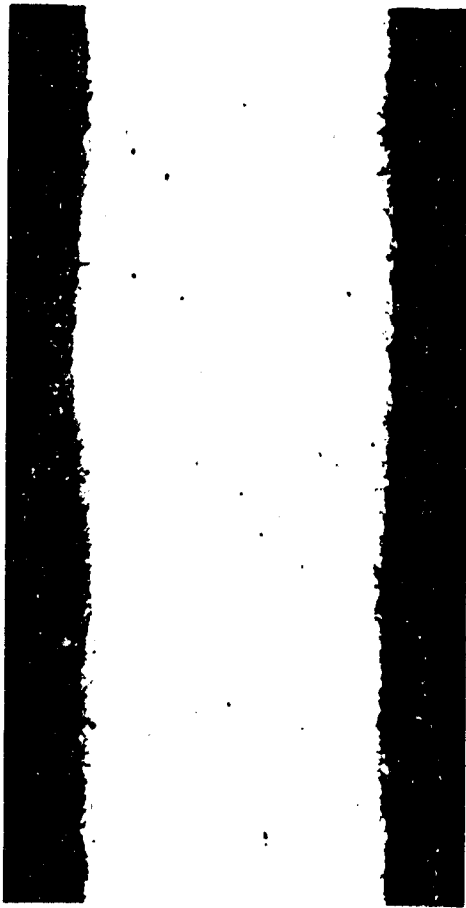
FIG. 33

Specimens for metallographic examination were taken in areas of various amounts of distortion. Figure 33 shows heavy oxidation and a tendency towards intergranular oxidation at the metal-heavy scale interface. Thicknesses of the specimens varied considerably due to the amount of oxidation involved. Figure 34 shows the microstructure at one surface. The structure contains many carbides and sigma phase. The sigma phase was present throughout the cross-section of all specimens examined. The carbides were present at both surfaces of all specimens. Where material was thinned considerably many carbides were present throughout the cross-section.

SAMPLE NO. 11 - SHOWING  
HEAVY OXIDATION OF  
BAFFLE

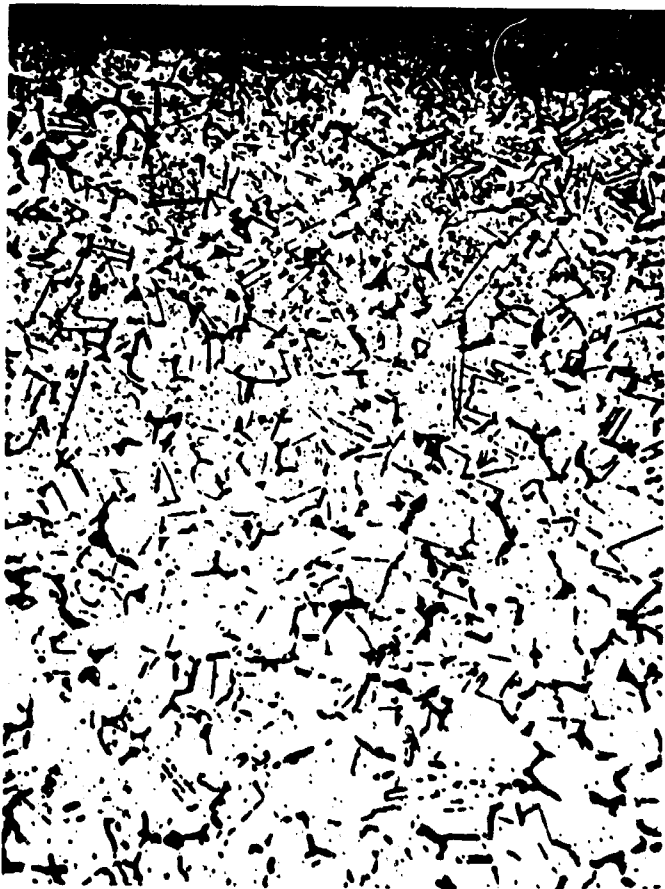
FIG. 34

SAMPLE NO. 11 - SHOWING  
CARBIDES AT INSIDE SURFACE  
OF BAFFLE (TOP) AND SIGMA  
PHASE IN GRAIN BOUNDARIES

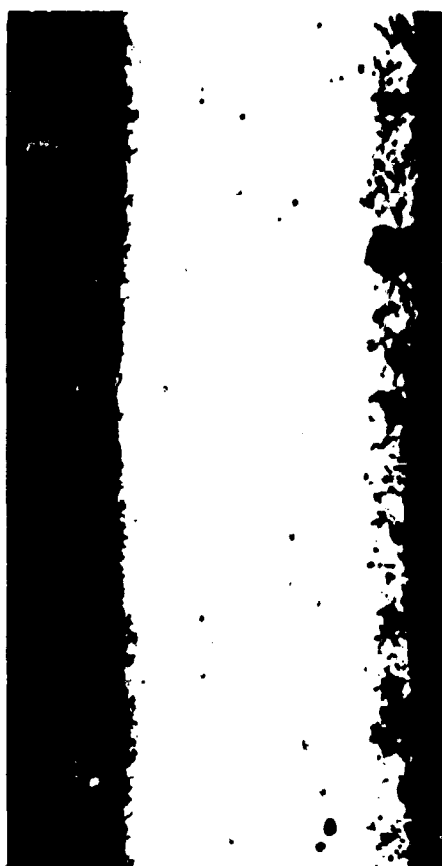
FIG. 36 SAMPLE NO. 12 - SHOWING (A) OXIDATION  
AT SURFACES AND (B) DEEPER PENETRATION  
AT VARIOUS LOCATIONS ON INSIDE SURFACE

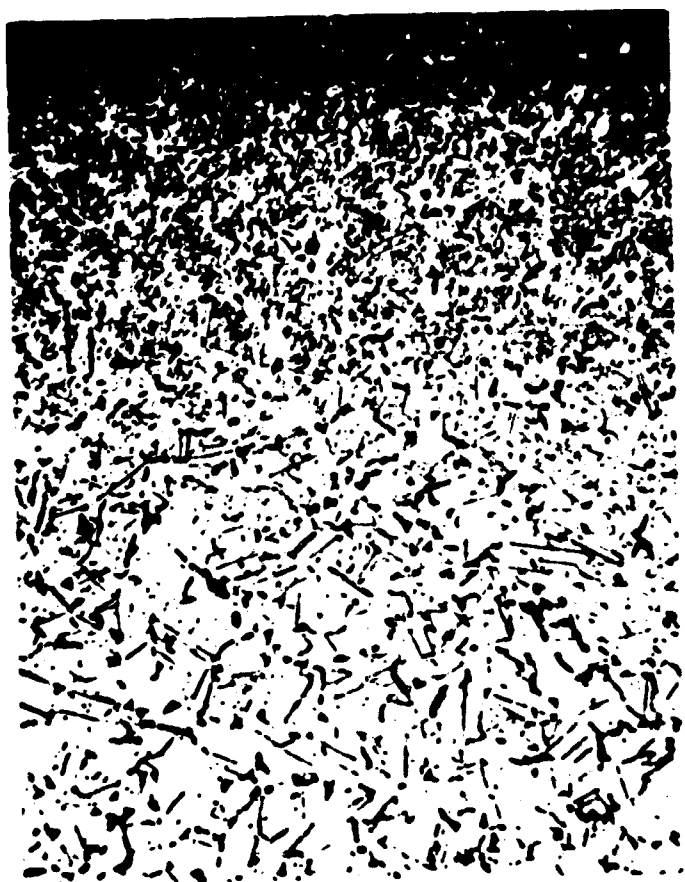
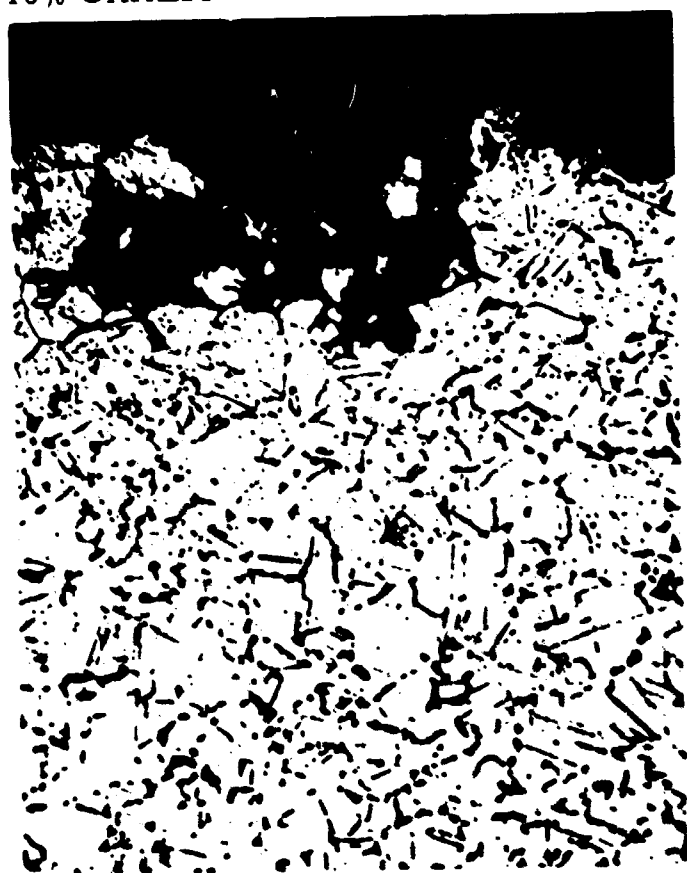
FIG. 38 SAMPLE NO. 12 - SHOWING (A) SIGMA PHASE AND CARBIDES AT THE OUTSIDE SURFACE AND (B) SIGMA PHASE WITH MUCH LESS CARBURIZATION AT THE INSIDE SURFACE

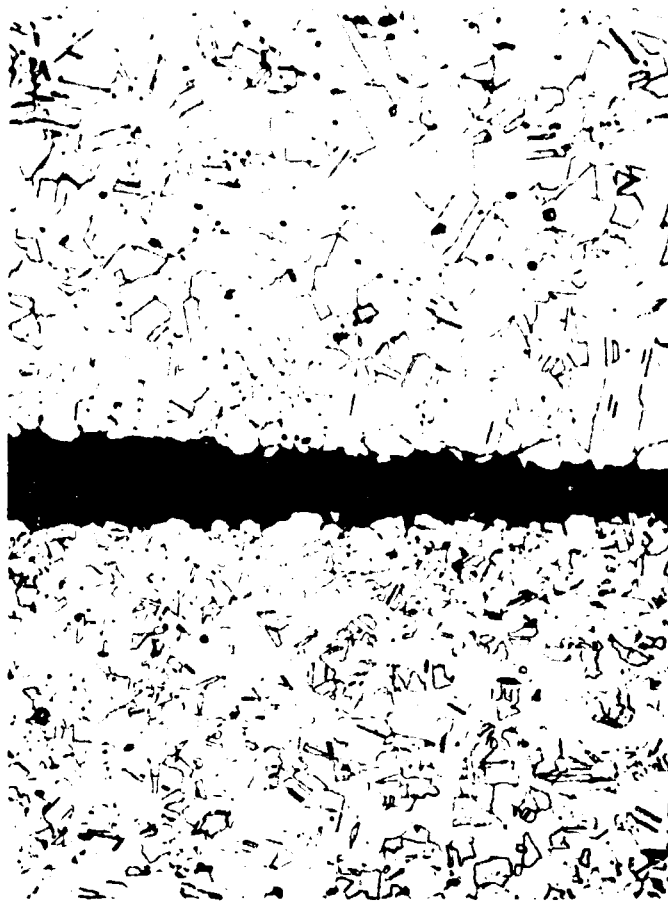
FIG. 40

SAMPLE NO. 14 - SHOWING  
STRUCTURE AT A LOCATION  
ON SIDE OF TAILPIPE  
OPPOSITE TO THAT WHICH  
CRACKED

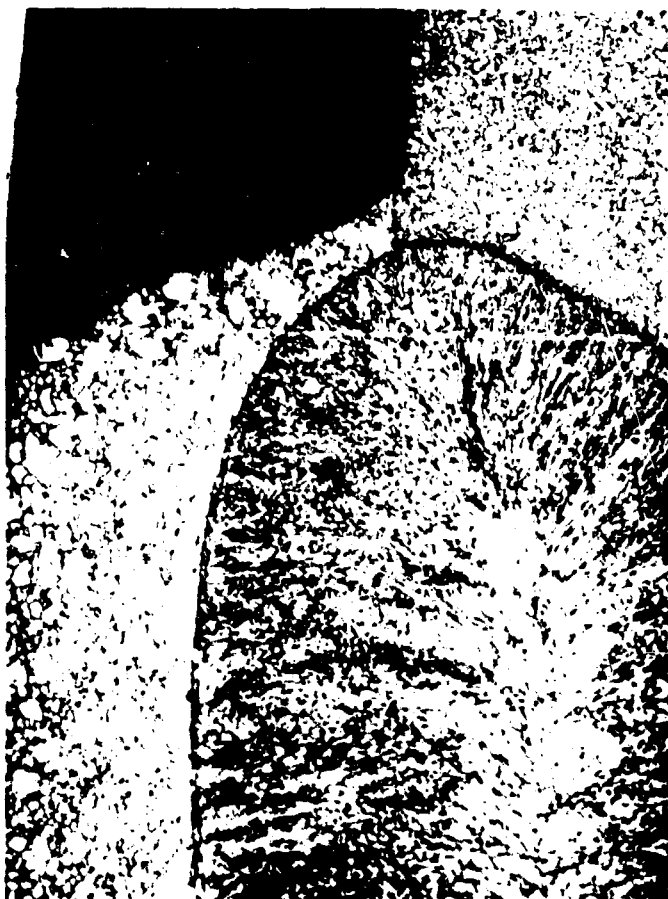
FIG. 41

SAMPLE NO. 14 - SHOWING  
SPOT WELD AND COURSE  
OF CRACK IN BASE METAL.

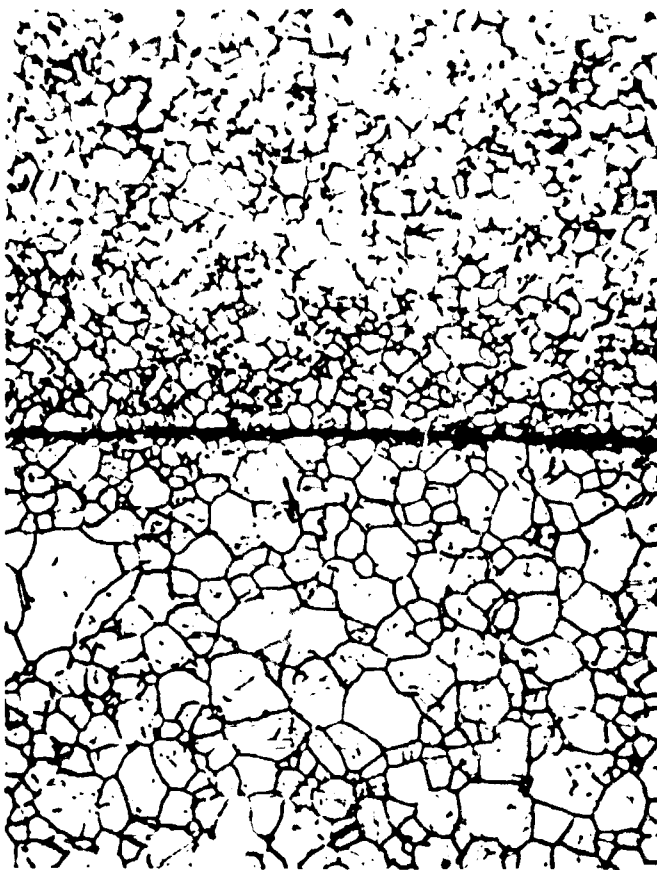
FIG. 42

SAMPLE NO. 14 - SHOWING GRAIN BOUNDARY PRECIPITATE AT A LOCATION NEAR THE SPOT WELD AND THE CRACK.

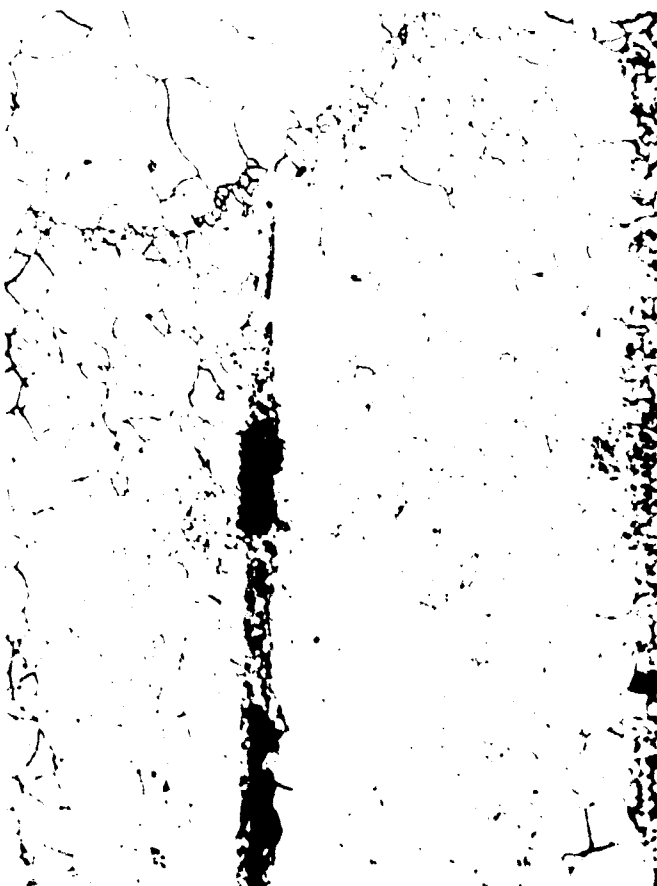
FIG. 43

SAMPLE NO. 14 - SHOWING THE STRUCTURE OF A PORTION OF THE SPOT WELD AND THE BASE METAL NEAR THE FUSION WELD. THE GRAIN SIZE IS LARGER THAN AT OTHER LOCATIONS EXAMINED. THE STRUCTURE SHOWS A GRAIN BOUNDARY PRECIPITATE.

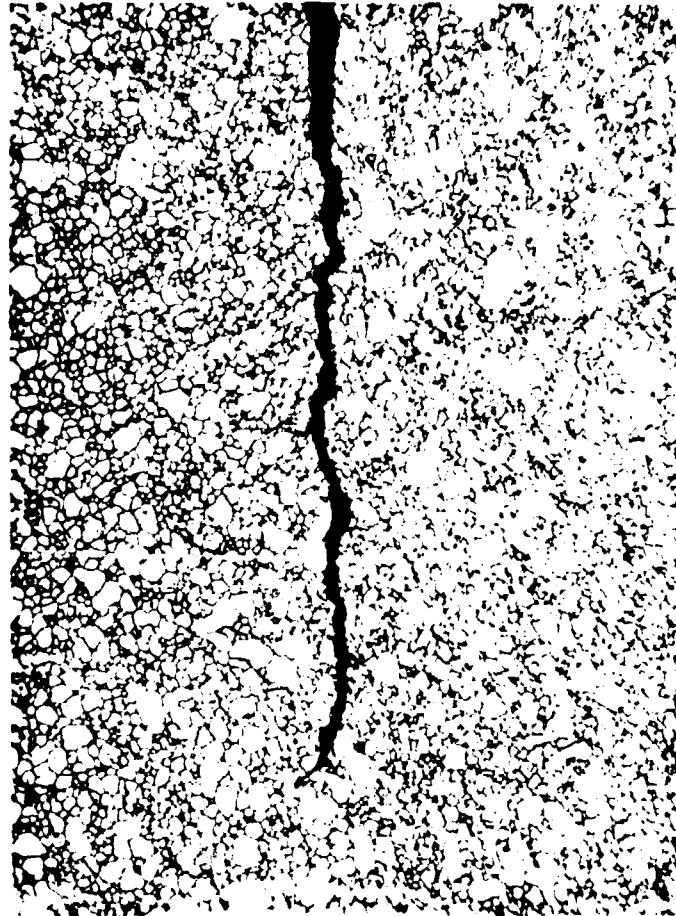
FIG. 44      SAMPLE NO. 14 - SHOWING A BRANCH OFF THE MAIN CRACK
